# **Seismic Behaviour and Retrofitting of the Poggio Picenze Historical Centre Damaged by the L'Aquila Earthquake**

**A. Formisano**  
**Department of Structural Engineering**  
**University of Naples “Federico II”, Naples, Italy**

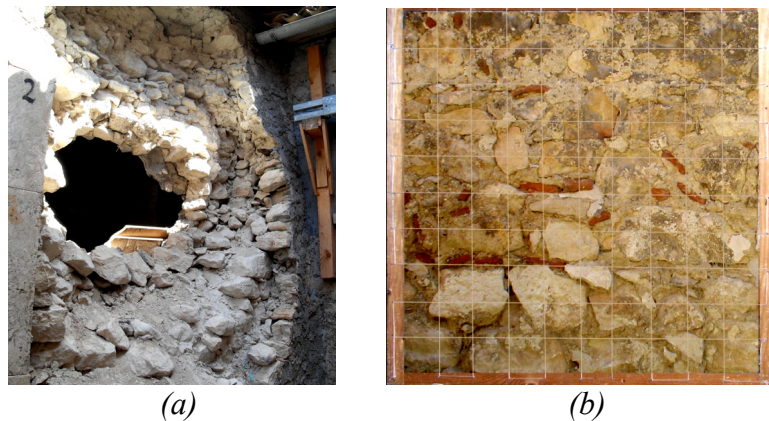
Within the area of Poggio Picenze the main masonry typology is based on small size stones with no transversal section links, no stretcher elements, no bricks layers and no sufficient wedges elements (see Fig. 7).

Therefore, due to the above lacks, a failure of the wall external layers occurs because of buckling phenomena.

Figure 7. A masonry panel detected in the Poggio Picense area and a 1m x 1m masonry sample (b).

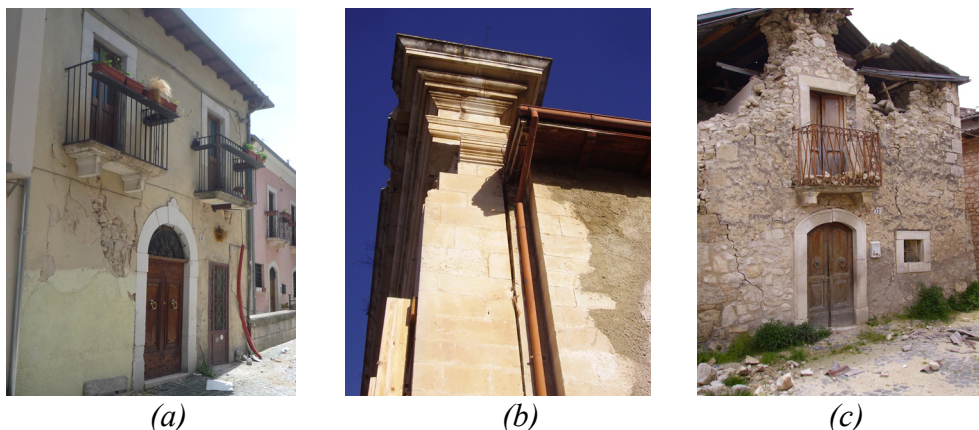
During in situ investigations of several masonry buildings, important failure patterns into both vertical and horizontal structures have been detected. In particular, the following main collapse mechanisms have been identified (Figs. 8 and 9):

- global in-plane mechanisms, consisting of storey shear failures due to diagonal shear cracks in the masonry piers; local crushing of the masonry with or without expulsion of material;
- global out-of-plane mechanisms, characterised by either whole or partial wall overturning or walls bending collapse, generally triggered by vertical cracks at the wall corners; rocking;
- other global mechanisms, such as irregularity among adjacent structures and floor and roof beam unthreading, due to permanent deformation of either tie-beams or their anchorages; vertical cracks along the interface between two adjacent buildings.
- local mechanisms, especially consisting of lintel or masonry arch failure, local weakness, corner overturning in the upper building part caused by diagonal and vertical cracks within the masonry spandrels or cracks in the keystone arches.

Figure 8. Main global collapse mechanisms: (a) in-plane, shear failures due to diagonal shear cracks in the masonry piers; (b) out-of-plane overturning; (c) diagonal wedge and horizontal bending.

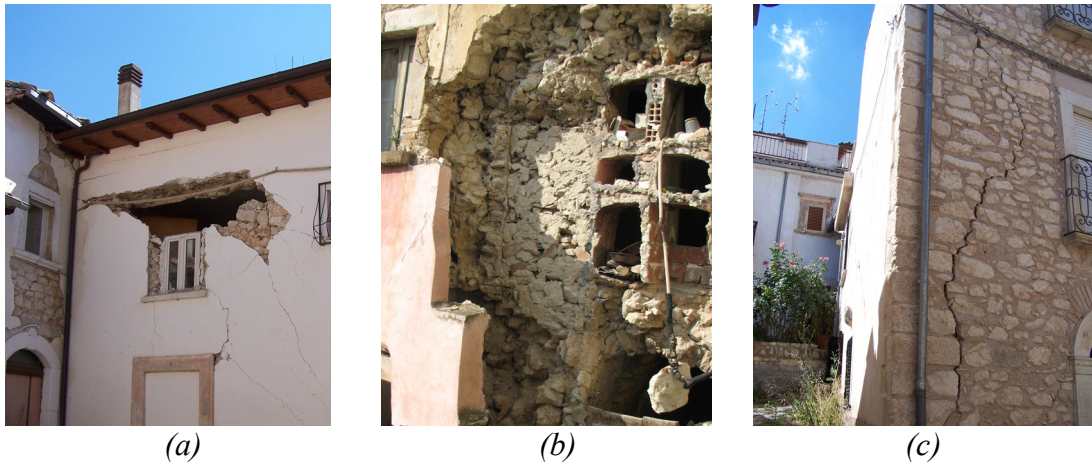
Figure 9. Main local mechanisms: (a) lintel failure; (b) collapse of the masonry external layer; (c) vertical cracks in masonry piers.

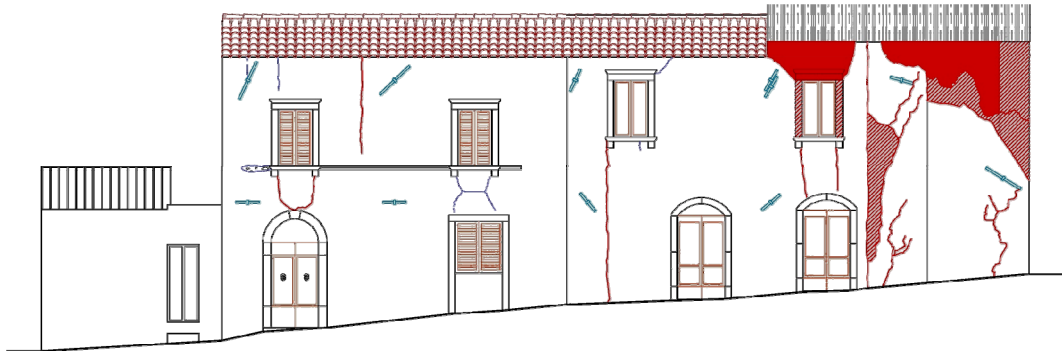
However, if we look at the damage pattern of one of longitudinal facades of the aggregate after earthquake (Fig. 11), it is found that the whole block has not played the role of structurally continue system. In fact, the not rational interventions developed in the past years finalized to the building modernization have led, together with the lack of roof-top masonry panel connections, to the devastating mechanism of the observed façade damage.

Figure 11. Post-earthquake damage survey of a longitudinal facade of the study aggregate.

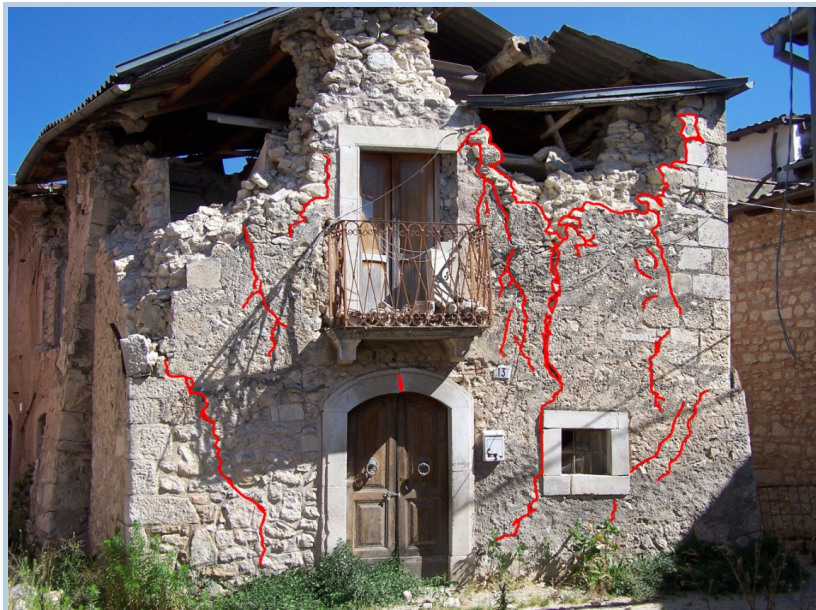
On the other hand, the facade on the right of the longitudinal facade above examined is damaged with second mode local failure mechanisms (Fig. 12). Shear cracks show as the façade left part is rotated into anti-clock way, with detachment of a panel portion producing a vertical crack propagated up to the opposite panel side, and a relative slip among arch key elements is occurred.

Figure 12. Post-earthquake damage survey of the transversal facade of the study aggregate.

In addition, the above described mechanism involves part of the angle panel in common with the longitudinal facade before investigated. Thanks to both the good connection between orthogonal walls and the presence of a steel tie-beam, only the top part of the masonry angle is failed.

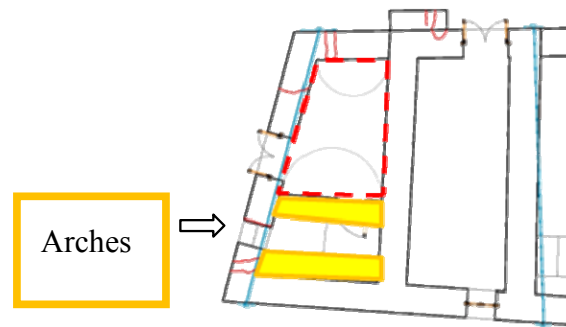
On the right side of the transversal facade, due to two arches located orthogonally to the same facade (Fig. 13), two sub-vertical cracks are developed. So, the resulting masonry panel confined by these two vertical cracks, not having a monolithic behaviour, does not allow the formation of some mechanism type, but shows the collapse of its external masonry layer.

Figure 13. Post-earthquake damage of the transversal facade of the study aggregate due to the presence of arches orthogonal to the facade.

This is produced by the incapacity of the masonry wall, composed of irregular masonry stones without transversal connections within its thickness, to exhibit out-of-plane overturning due to the premature material disaggregation, which inhibits the development of the rotational plastic hinge necessary to the mechanism activation.
