Strengthening of Masonry Buildings by Post-Stressing: The Verticalisation Method

Abstract

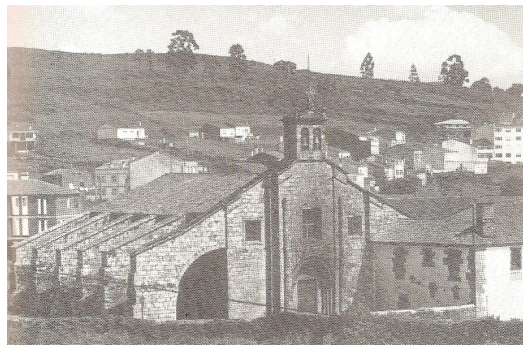
Figure 2: Church of *Santa María la Real de Sar Y Mayor*

A very interesting case that has been studied was the church of Santa María la Real de Sar Y Mayor, on the outskirts of Santiago de Compostela, located along the river Sar in Spain, Figure 2. The construction of this monument began in 1134 and on 14 August 1895 was considered a National Monument having suffered throughout its history various repairs and restoration by the Spanish General Directorate for National Buildings and Monuments.

This monument is famous due to the slope of the interior columns and exterior walls, giving visitors the impression that the arcs of coverage tend to fall apart. In the 16th century the inclination of the walls and columns reached high values, which led to the collapse of the central arch, Figure 3.

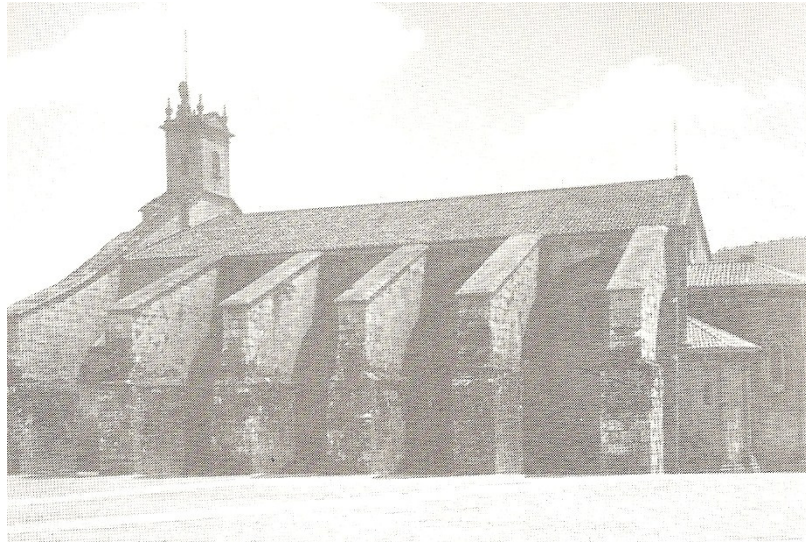
Figure 4: Configuration of the buttresses

In the reconstruction of the church the central arch remained supported on bowed columns and walls, but to provide the stability that had been missed earlier and that caused the collapse, exterior buttresses were constructed, with very high dimensions as the Figures 4 and 5 illustrate.

These buttresses balance and transfer counter force to the outside, in direct balance by preventing destabilization through the lateral arms. The pillars inside the church still remain inclined, as shown in the accompanying figure. The instability of the church of Santa Maria de Sar was due to poor design of formal arcs of aisles shown in Figure 6.
