Weigh in Motion Measurement and Experimental Fatigue Assessment of a Railway Bridge

G. Chellini¹, M. Orlando², W. Salvatore¹, G. Sorrentino³ and M. Tisalvi³

Abstract

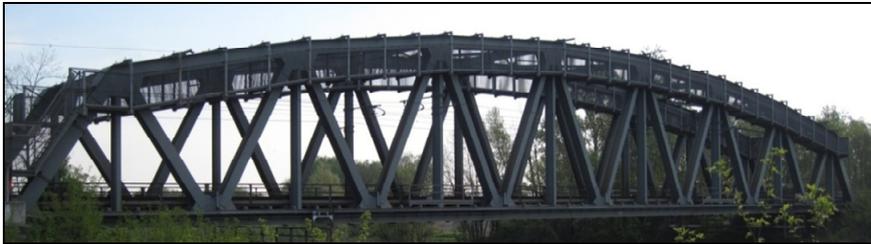
Figure 1: the Panaro Bridge.

The Panaro Bridge (Figure 1) is a bow string steel bridge along the Bologna - Verona railway line.

The bridge span length is equal to 75.6 meters and the height of cross section of the bridge varies from 7 to 11 meters. Its structure, composed by welded elements, consists in lower and upper strings, vertical and diagonal beams, main cross girders, lower and upper bracing diagonals and local track bracing system. All joints between the structural members are realized adopting riveted solutions. Support system is composed by two fixed steel bearings and two unidirectional steel bearings, as reported in the Figure 2.

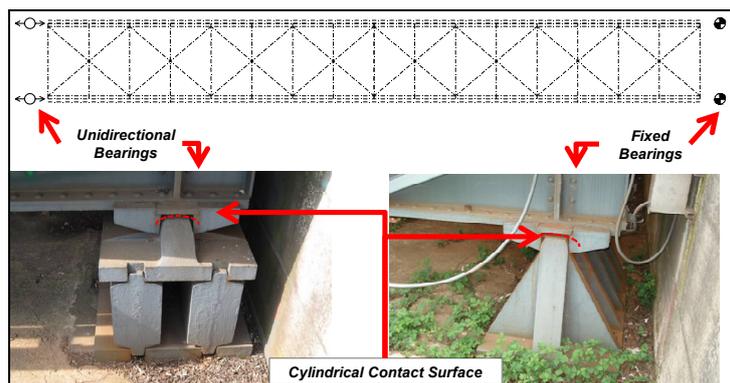
Figure 2: supporting scheme of the Panaro Bridge.

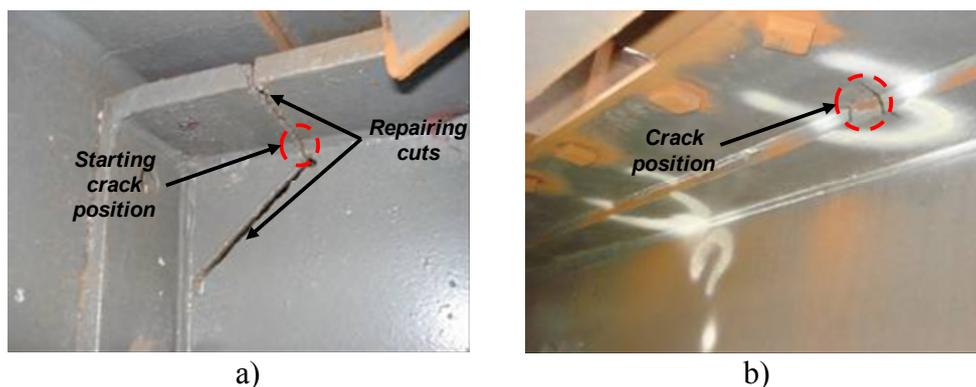
Figure 3: fatigue damages due to distortion and vibration phenomena, Panaro bridge.

During its service life, the Panaro Bridge was subjected to an heavy railway traffic and some of its secondary elements showed fatigue damages due to distortion and vibration phenomena (Figures 3a and 3b).

In particular, as reported in the Figure 3a, all the track bracing cross beams experienced the same fatigue crack located near its connection to the secondary longitudinal girders. In order to stop the crack propagation, Italian Authority decided to cut the profiles and to remove external bolts, changing the scheme of the connection joint between the damaged components and the longitudinal girders from fully fixed to hinged. In the Figure 3b, the typical fatigue damage found in the welding between the secondary longitudinal girders and the connection plates supporting the wooden sleepers is showed.

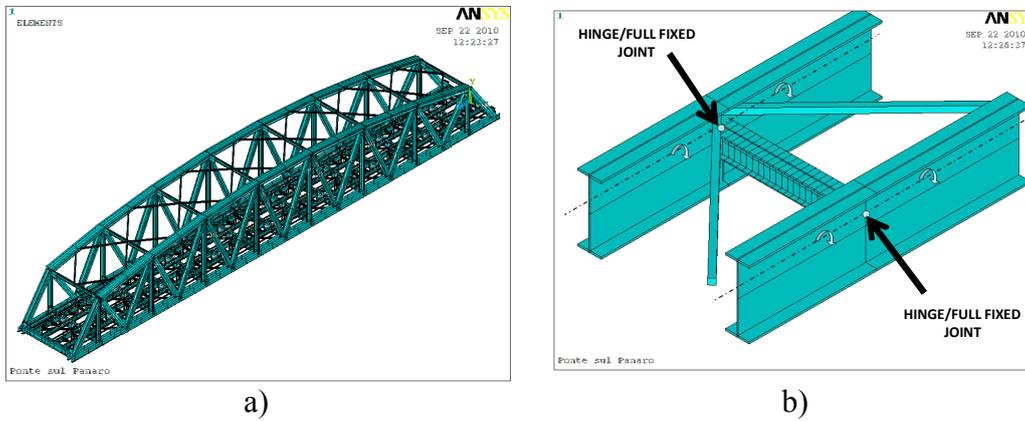
Figure 4: a) finite element global model and b) restraint modification of the secondary cross beam

Two finite element beam models were developed by the ANSYS[®] software: the first model represents the original resistant scheme of the bridge, characterised by the track bracing cross beam fully fixed to the longitudinal girders (Fully fixed model); the second represents the actual resistant scheme of the bridge, where connections at the end of the restraint of the secondary cross beam are hinges (Hinge model), as showed in the Figures 4a and 4b.

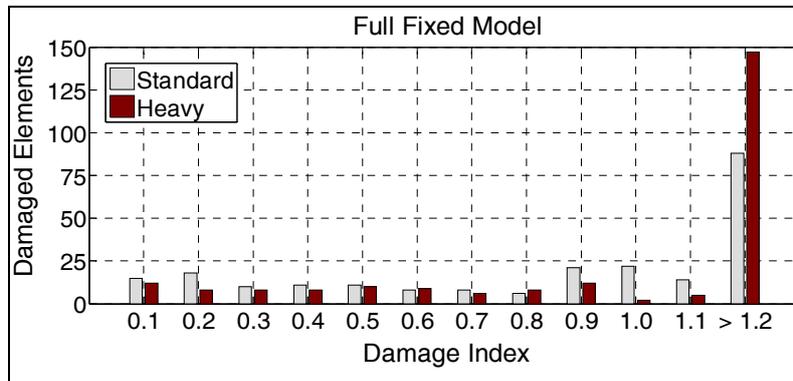
Figure 5: results of the standard fatigue assessment of the fully fixed model – standard and heavy traffic mix

Main results of the performed analyses, indicated in the Figures 5 and 6, showed that, both for the fully fixed model and for the hinge model, damage indexes were greater than 1, i.e. elements not safe in terms of fatigue strength, at the connection joints between vertical beams and lower/upper stringers (actually undamaged), as reported in the Figure 7a.

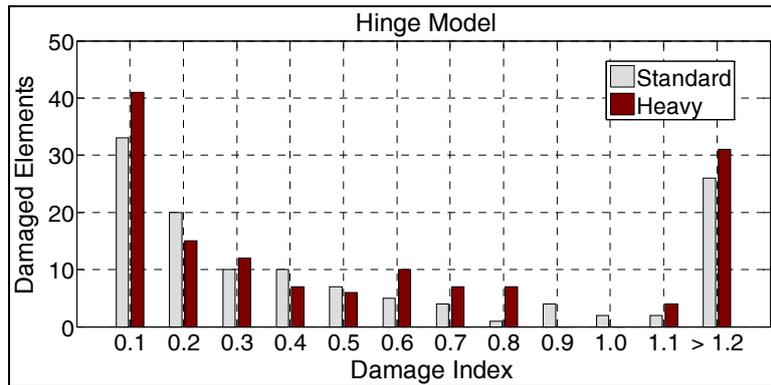
Figure 6: standard fatigue assessment of the hinge model – standard and heavy traffic mix

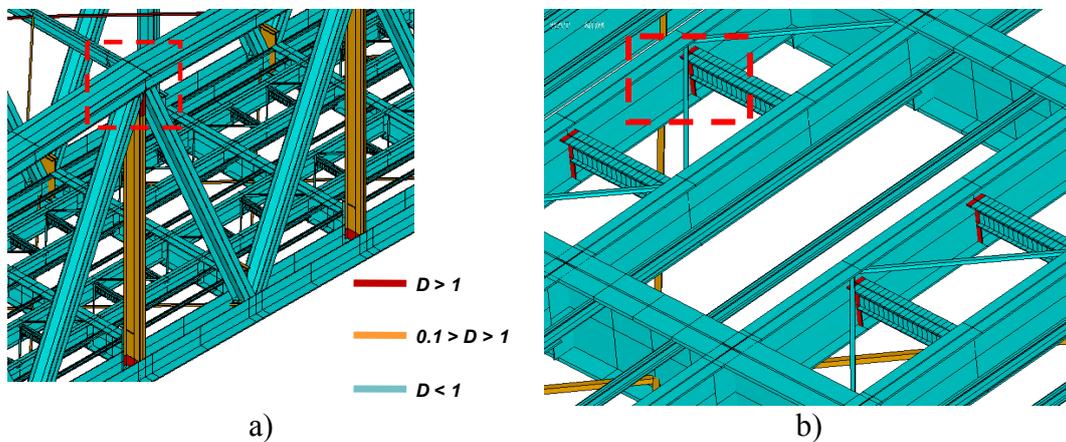
Figure 7: a) joint between vertical beams and lower/upper stringers (hinge model) and b) damaged section of the track bracing cross beam (fully fixed model)

On the contrary, the elements corresponding to the end sections of the track bracing cross beam, resulted damaged only in the fully fixed model, as really occurred, see Figure 7b, but the damage index, nearly equal to 1.2, i.e. a life cycle of 80 years, was not in agreement with the real observed damage. Indeed all of these components presented fatigue cracks just after 30 years.

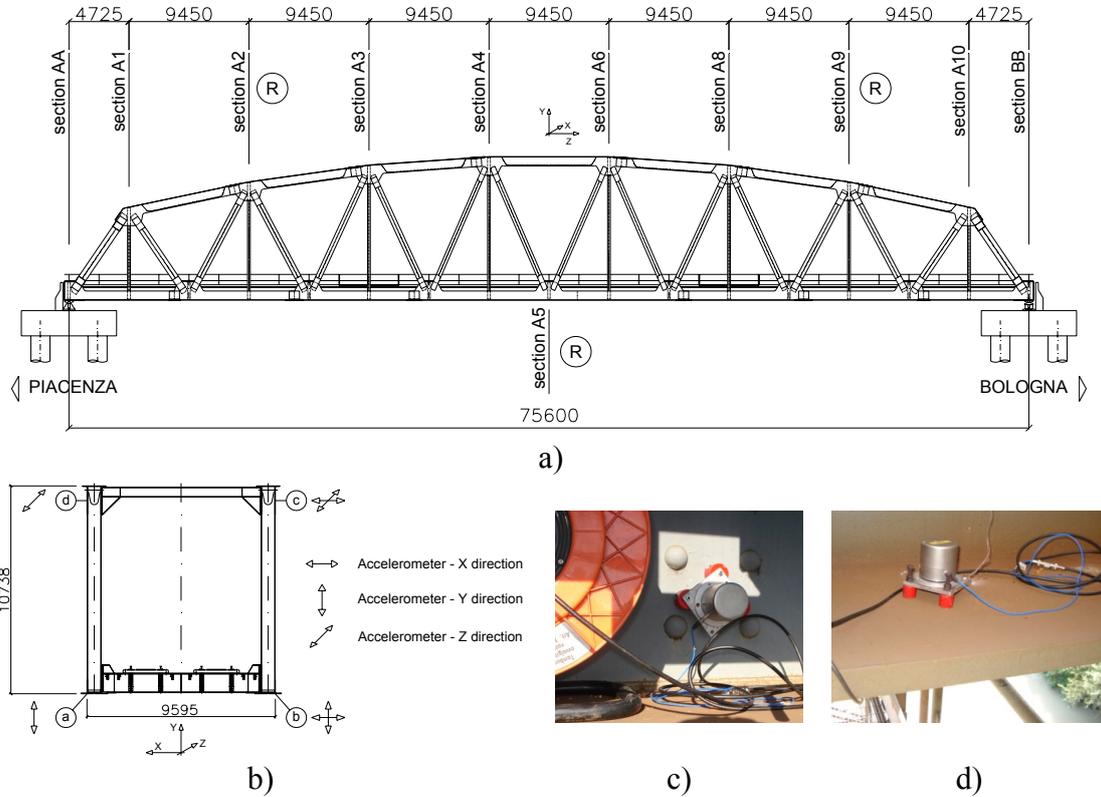
Figure 8: a) and b) layout of the global modal analysis test; horizontal (c) and vertical (d) accelerometers on main lower longitudinal beam.

Acceleration in both vertical and horizontal directions were recorded in correspondence of eight sections of the bridge. Mode shapes were then identified

Accelerations were recorded by PCB[®] accelerometers and LMS[®] Scadas acquisition unit adopting a sampling frequency of 400 Hz for time periods of about 15 minutes. Seven global modes were identified as reported in the table 1. In the Figure 9 shapes of the first two modes are reported.

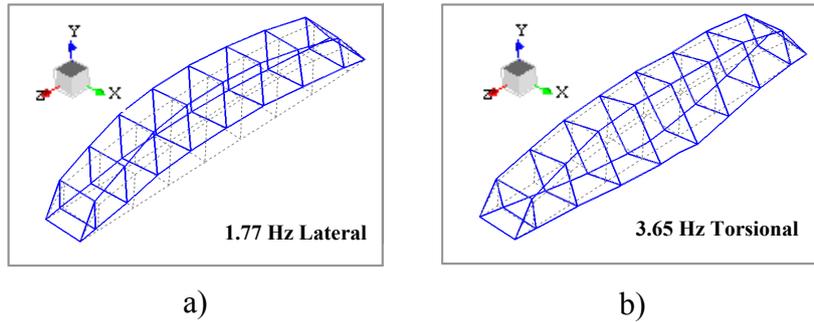
Figure 9: a) the 1st and b) the 2nd identified global mode shapes.

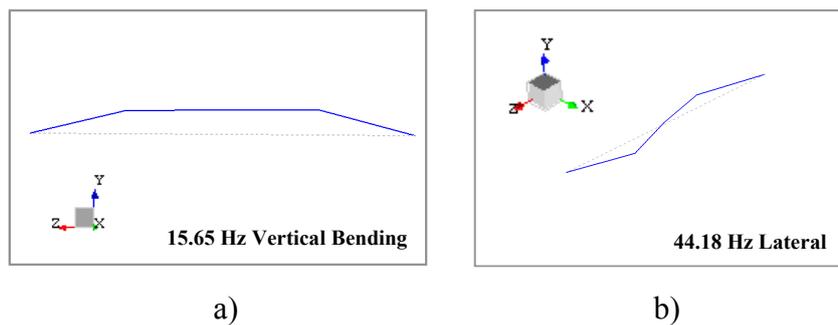
Figure 10: a) the 1st and b) the 2nd mode shapes identified for the track bracing cross beam.

OMA was also applied for the evaluation of local modes of the track bracing cross beams. In this case, by a single acquisition performed with the aforesaid record setting, it was possible to identify three structural modes, as showed in the table 2. In the Figure 10 the first and the second mode shapes are showed.

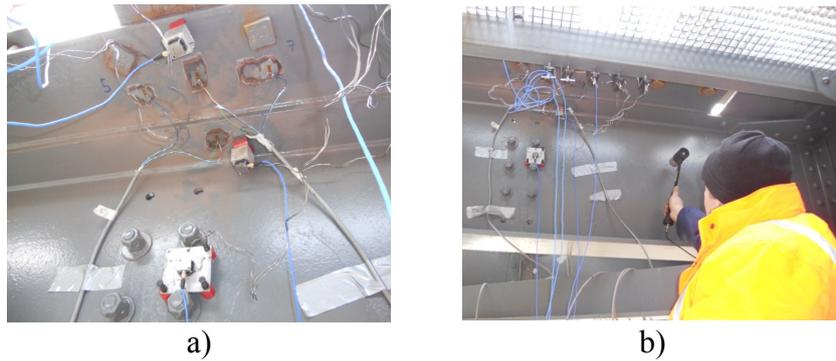
Figure 11: a) layout and b) execution of impact testing on the connection plate between longitudinal girders and wooden sleepers.

OMA wasn't applicable to the connection plate between longitudinal girders and wooden sleepers, as global modes showed a great influence in such analysis. For this reason, the impact testing technique was applied, as reported in the Figure 11.

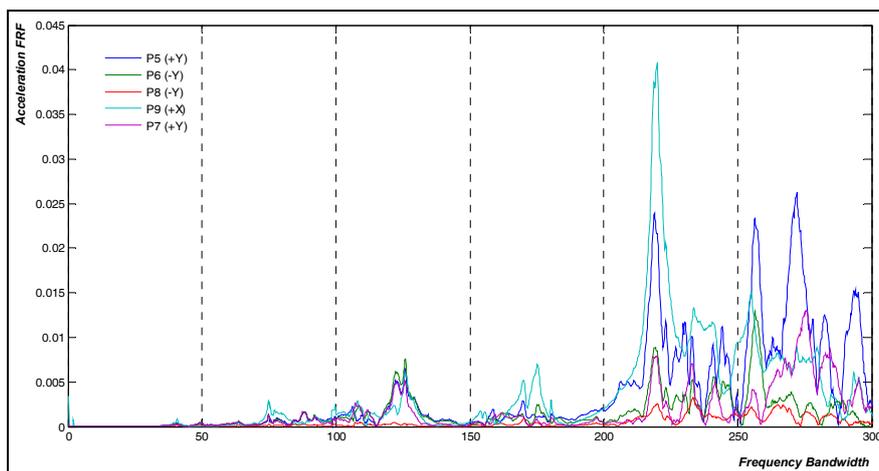
Figure 12: FRF evaluated through the impact test.

Data processing of impact test acquired signals are still ongoing. In the Figure 12 an example of the Frequency Response Functions (FRF's) is reported.

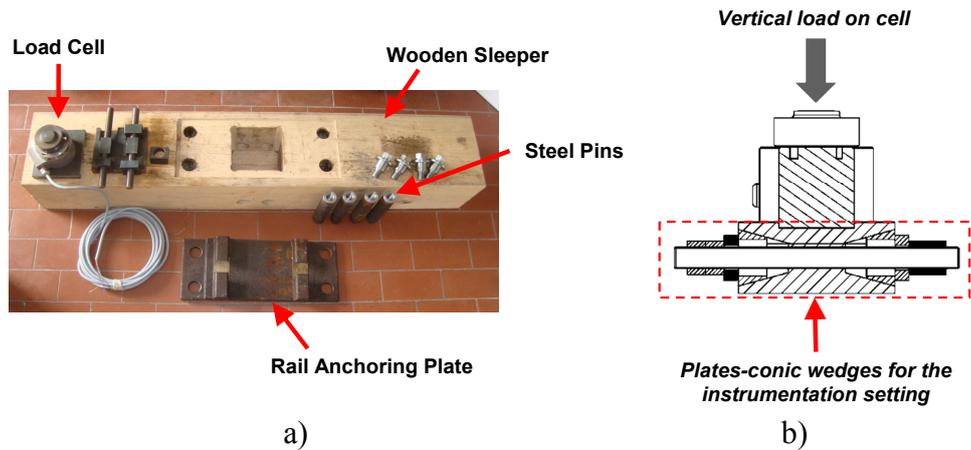
Figure 13: a) Rev.1 of the developed weighting in motion system and b) instrumentation setting system of the load cell

The first revision of the instrumented sleeper (Rev.1), reported in Figure 13a, was designed and realized for the validation of the proposed measure.

The working principle of such system consists in the possibility of the rail anchoring plate to slide over the four steel pins located in the wooden sleeper, in order to apply the vertical load due to the train wheels directly on a load cell mounted in the wooden sleeper. The load cell is positioned over a setting system composed by four conic wedges and two machined plates, as reported in the Figure 13b. Such system is necessary to guarantee the suitable contact between the load cell and the rail anchoring plate, a basic requirement for this measurement, also taking into account of rail misalignment imperfections.

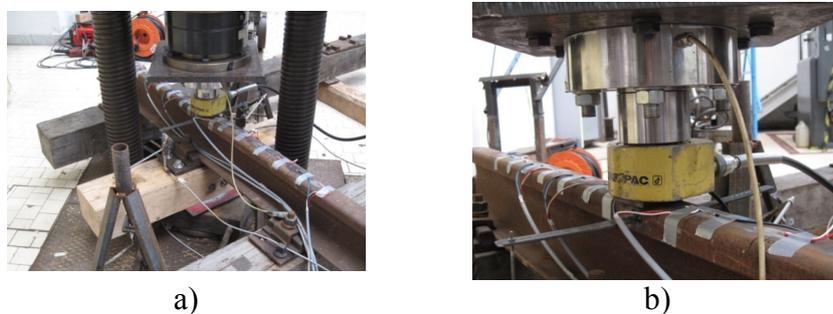
Figure 14: a) global layout of the validation test and b) a particular of the hydraulic jack.

A validation test of the developed prototype of the Rev.1 was then performed with the following test configuration. The equipped sleeper was mounted between two ordinary sleepers in order to reproduce the real operating conditions. A part of rail was connected to the three sleepers and the load was then applied by the use of an hydraulic jack, as showed in the Figure 14. Measurements of rail strains using electric gauges and measurements of vertical displacement of the load application point on rail using LVDT sensors were performed.

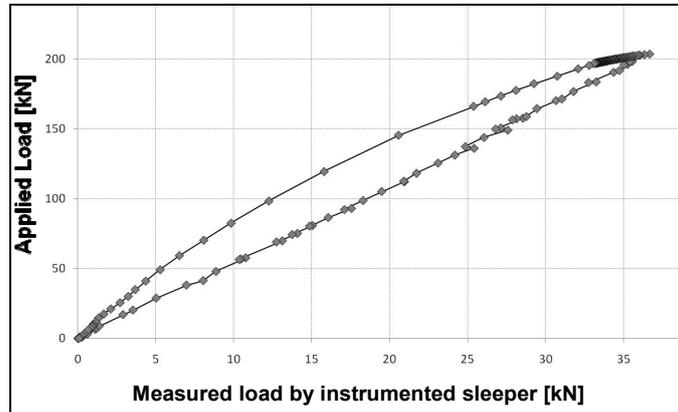
Figure 15: load cycle measured by the validation test

On the basis of the measures of applied load by using the proposed instrumentation, it was possible to observe that such weighing in motion system guarantees a linear response, but a suitable calibration on field is necessary in order to extract correct values of train axle loads, as showed in the Figure 15, which reports the load cycle of one of experimental tests.

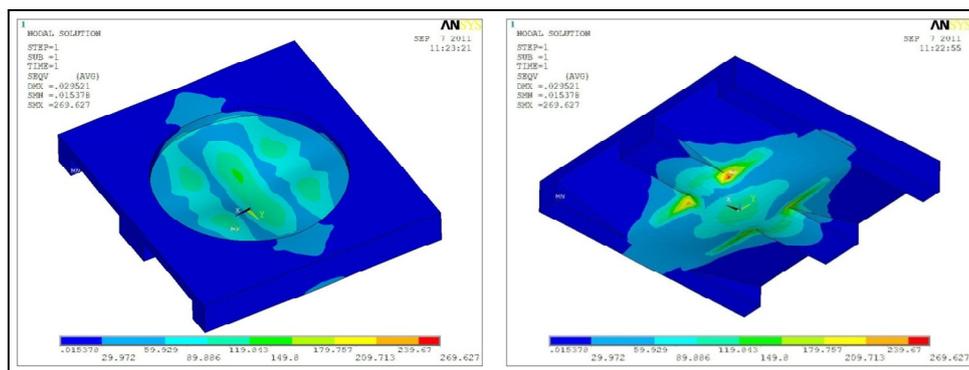
Figure 16: numerical model of the upper steel plate of the Rev.1 setting system.

In order to verify the instrumentation durability, numerical solid models of all the components were developed through ANSYS[®] software. Static analyses of these steel components performed through the application of loads foreseen in Eurocode 1 [8], highlighted the needs of a design review to reduce stresses and to avoid fatigue damage. Maximum Von Mises equivalent stress in the upper steel plate of the system was equal to 270 MPa, see Figure 16, greater than the fatigue limit for steel grade S375 equal to 220 MPa.

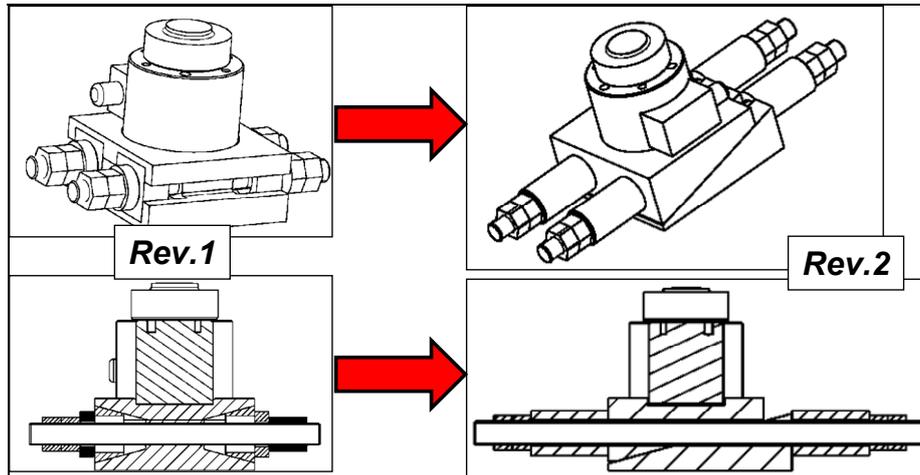
Figure 17: main changes in instrumentation setting system.

To these purposes, a new revision (Rev.2) of the instrumentation was developed. Main changes focused on the instrumentation setting system composed by plates and

conic wedges, as showed in the Figure 17. Static analyses performed on the Rev.2 showed a general decrease of stresses. Maximum Von Mises equivalent stress in the upper plate of the setting system was equal to 105 MPa, lower than fatigue limit, see Figure 18.

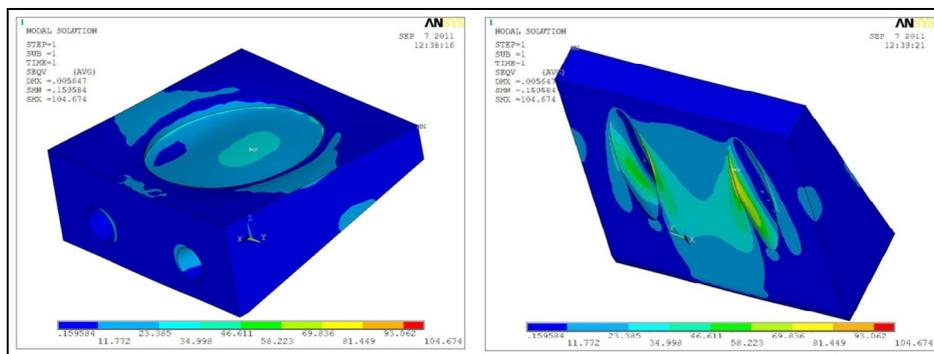
Figure 18: numerical model of the upper steel plate of the Rev.2 setting system

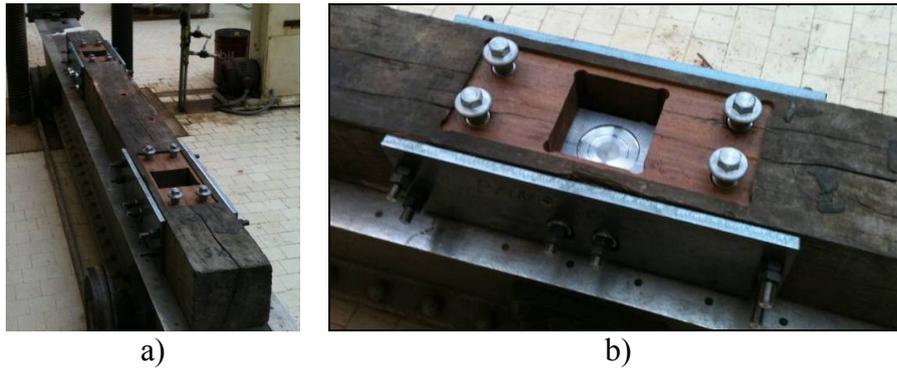
Figure 20: Rev.2 of the instrumented sleeper

Finally, final version of the developed equipped sleeper was tested adopting the same test configuration of Rev.1, as showed in the Figure 20.

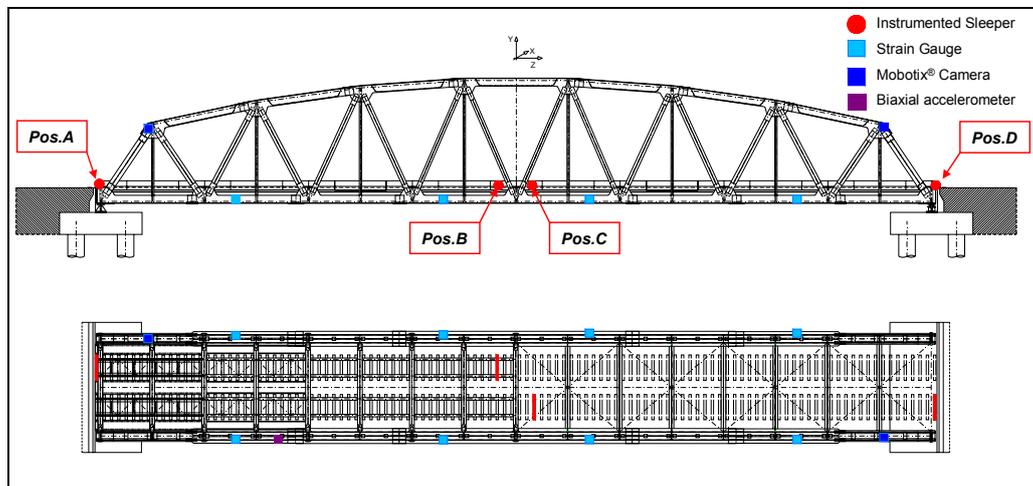
Figure 21: layout of the developed long-term monitoring system.

The layout of the long-term monitoring system is reported in the Figure 21.

Such system is composed by: four instrumented sleepers, for the evaluation of train axle loads, train compositions and train velocities (Position A and Position D) and for the evaluation of train/bridge dynamic interaction forces (Position B and Position C); strain gauges installed on the main lower longitudinal girders for the evaluation of global effects on the bridge due to train passages; a biaxial accelerometer located on the quarter span length of the main lower longitudinal girder, for the evaluation

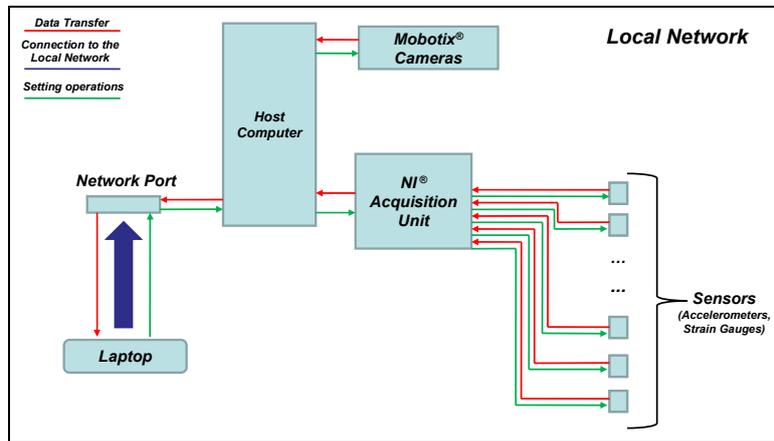
Figure 22: monitoring system local network

of global mode frequencies during the monitoring period analysing free vibrations after a train passage; two Mobotix[®] cameras for the visual estimation of train types; a National Instruments[®] acquisition unit connected to the aforesaid sensors types and controlled by an host computer via local network. In the Figure 22 a graphical representation of the local network installed on the bridge is reported.

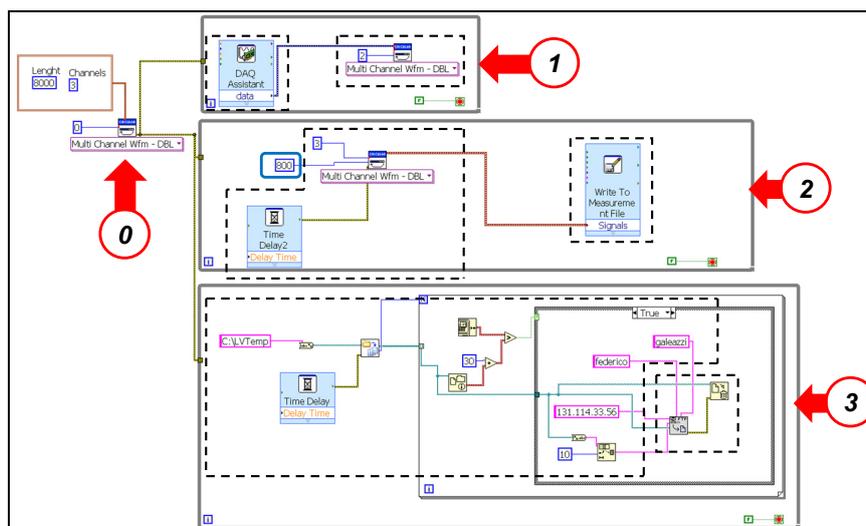
Figure 23: LabVIEW[®] procedure performed by the acquisition unit

Data acquisition and data storage are executed by a LabVIEW[®] procedure performed by the acquisition unit. This procedure is composed by the running of three parallel tasks: with reference to the Figure 23, after the buffer initialization (Point 0), the first task (Point 1) consists in the acquisition of sensor data with a sampling frequency of 800 Hz and in their storage in the buffer; the second task (Point 2) consists in the buffer reading every half second, writing in a file every 800 samples; and the third task (Point 3) is composed by the file transfer to the host computer deleting the original file on the acquisition unit after file transfer itself.

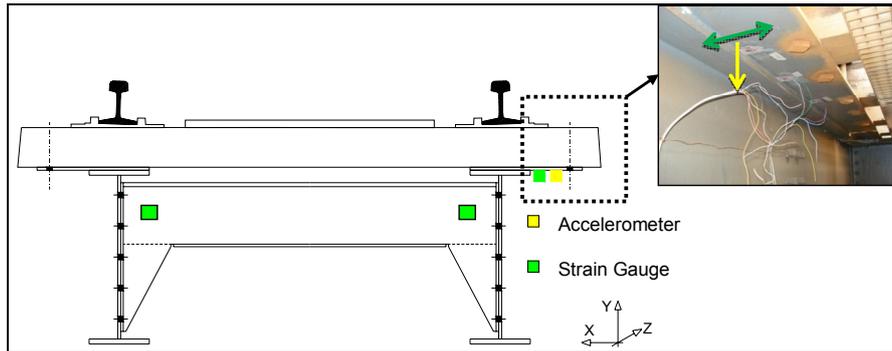
Figure 24: local monitoring system of the track bracing cross beam/connection plate between longitudinal girders and wooden sleepers.

In order to evaluate local dynamic behaviour and distortional strain patterns under train passages in critical details (i.e. vibration/distortion induced fatigue), the monitoring system foresaw the installation of three accelerometer and eight strain gauges for the local monitoring of the track bracing cross beam and the connection plate between longitudinal girders and wooden sleepers, as reported in the Figure 24, and the installation of six strain gauges for local monitoring of the joint between vertical beams and upper stringers, as reported in the Figure 25.

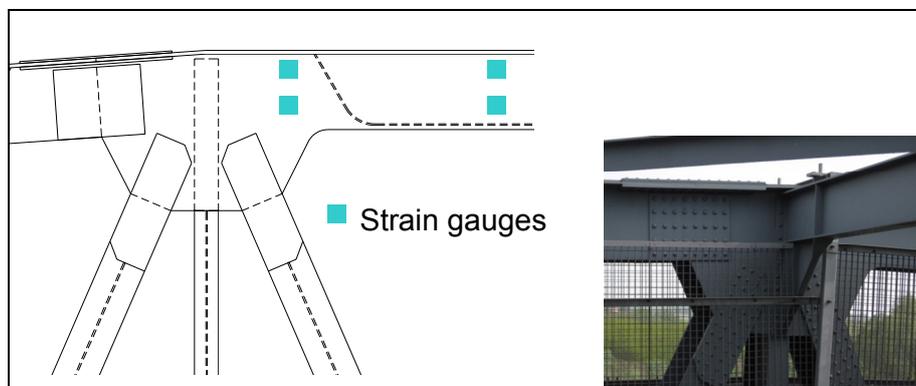
Figure 25: local monitoring system of the joint between vertical beams and upper stringers.

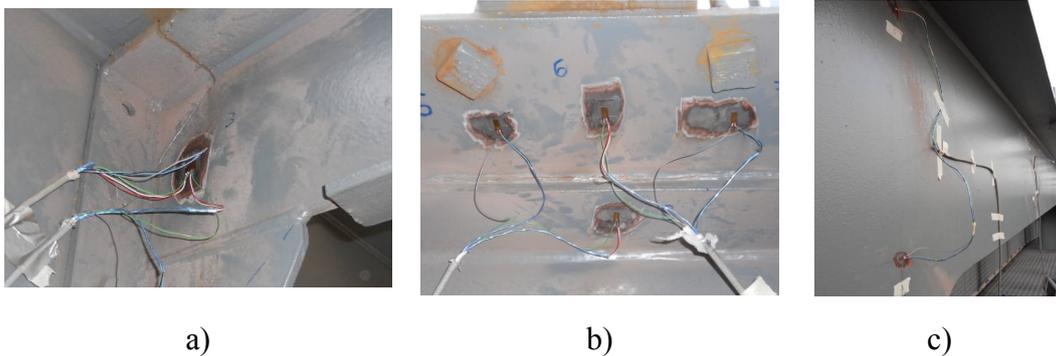
Figure 26: preliminary installation of local monitoring system for a) the track bracing cross beam, b) the connection plate between longitudinal girders and wooden sleepers, and c) joint between vertical beams and upper stringers.

The complete installation of the developed long-term monitoring system is still ongoing, only the strain gauges were mounted. In the Figure 26 such installations are represented.

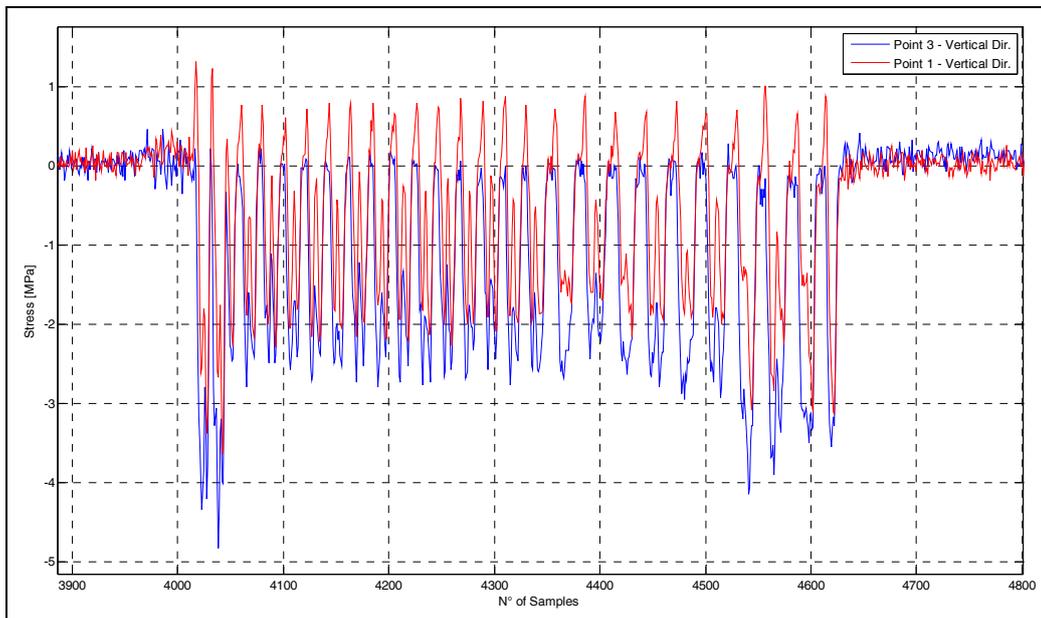
Figure 27: data extracted from local monitoring system installed on the track bracing cross beam – freight train passage

In any case, some interesting results were already extracted from mounted sensors. Indeed, by the analysis of the data extracted from the strain gauges located in the track bracing cross beam, as reported in the Figure 27, it was possible to observe that the local repair intervention on such detail reduced the stress field (the maximum stress variation was equal to about 5 MPa under a freight train passage).

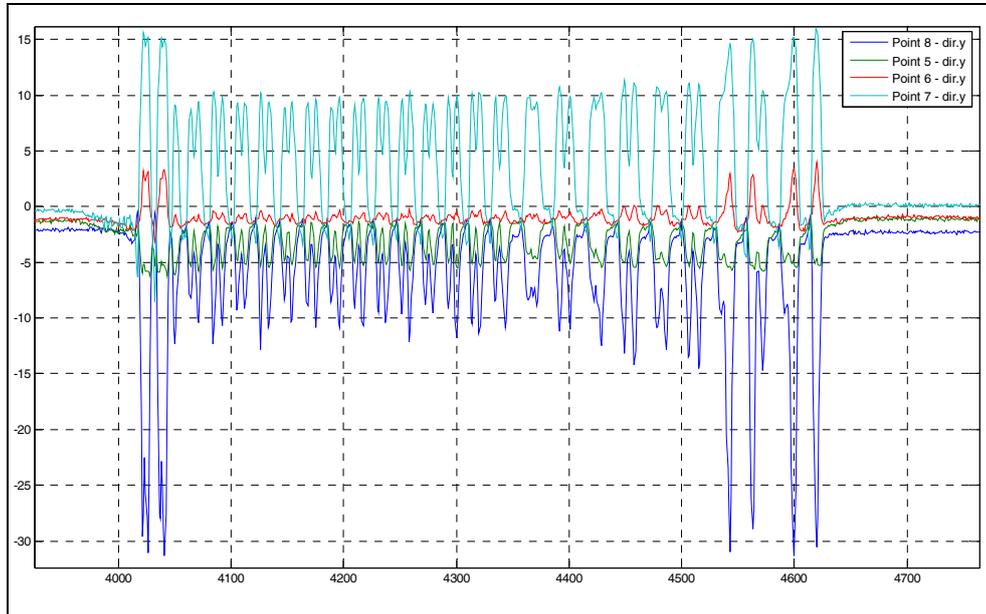
Figure 28: data extracted from local monitoring system installed on the connection plate between longitudinal girders and wooden sleepers – freight train

By the analysis of the data extracted from the strain gauges of the local monitoring system developed for the connection plate, it was possible to observe that the welding between the connection plate and the longitudinal girders was subjected to intense stress variations, and then to fatigue phenomena. For example, the maximum

stress variation due to a freight train passage is nearly equal to 45 MPa, as reported in the Figure 28.

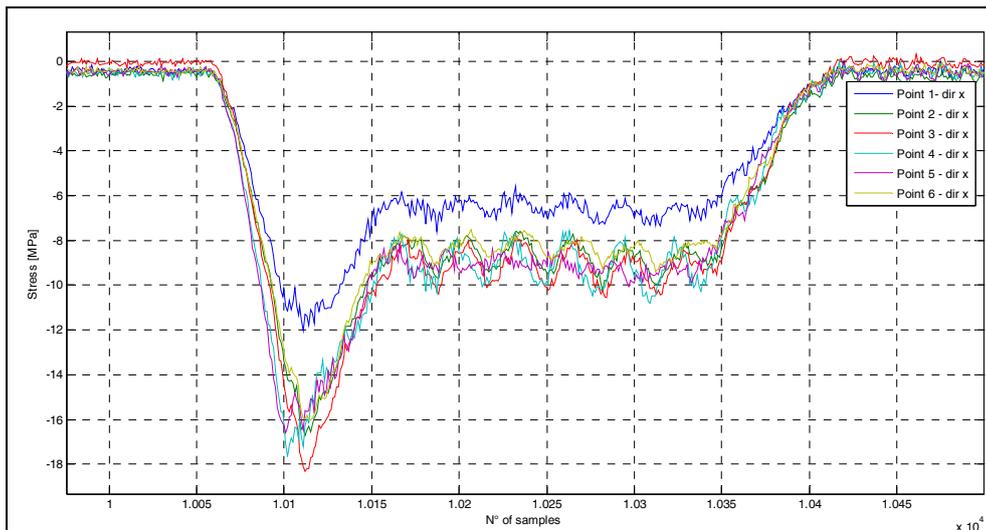
Figure 29: data extracted from local monitoring system installed on the connection joint between vertical beams and upper stringers.

By the evaluation of data extracted from the strain gauges located on the connection joint between vertical beams and upper stringers, it was possible to analyze the stress field in this details. For example, a peak stress value due to a freight train passage nearly equal to 18 MPa was found, as reported in the Figure 29.
