# **Seismic Behaviour and Retrofitting of the Poggio Picenze Historical Centre Damaged by the L'Aquila Earthquake**

**A. Formisano**  
**Department of Structural Engineering**  
**University of Naples “Federico II”, Naples, Italy**

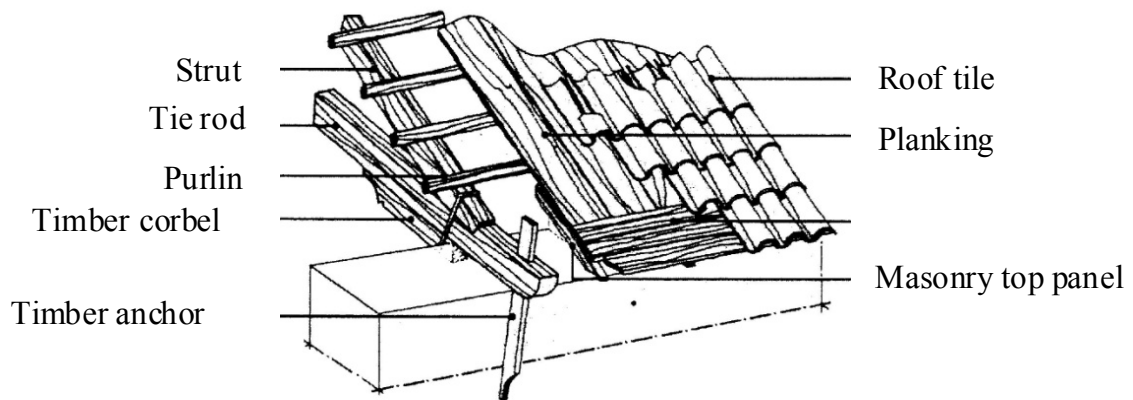
Figure 6. L'Aquila old buildings: a typical roof typology scheme [5].

With reference to the second seismic vulnerability source, it was noticed that after earthquake some constructions often failed due to either lack in maintenance of roofs or change of the coverage layers. In particular, information deriving from the knowledge of the original roof configuration showed that timber ties are generally hooked up by anchors to top panels outside (Fig. 6).

This valuable roof scheme was often replaced by dissimilar coverings, no effective during earthquake. As a consequence, four different roof conditions were noticed within the investigated small town, they being classified into the following four categories:

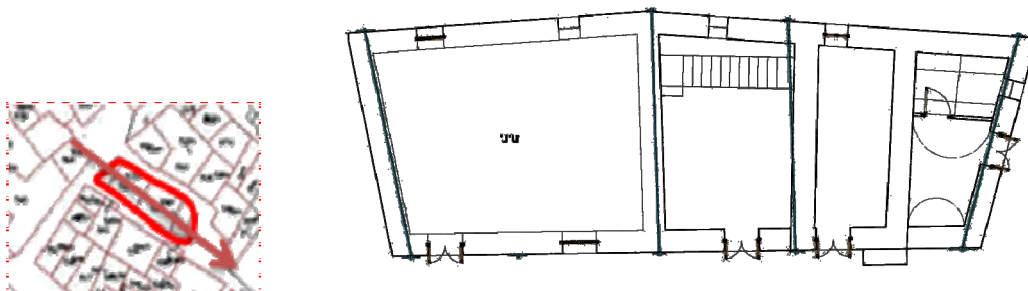
Figure 10. Block configuration and plan layout of the studied aggregate.

The building aggregate is developed linearly along the hillside with an elongated configuration of the block (Fig. 10) [6].

Masonry walls have thickness variable from 50 to 70 cm and the inter-story height changes from 3.00 to 4.50 m. Windows, often not aligned each other, are within the range [10-30%] of the masonry wall volume and are located at the right distance with respect to the wall intersections.

The aggregate building showing major damages is the head one, placed in a leading position at the maximum level. In fact, for this structural unit, three of the four external walls are exposed to seismic action effects and, therefore, it is more vulnerable than other aggregate buildings. Such buildings, other than represent

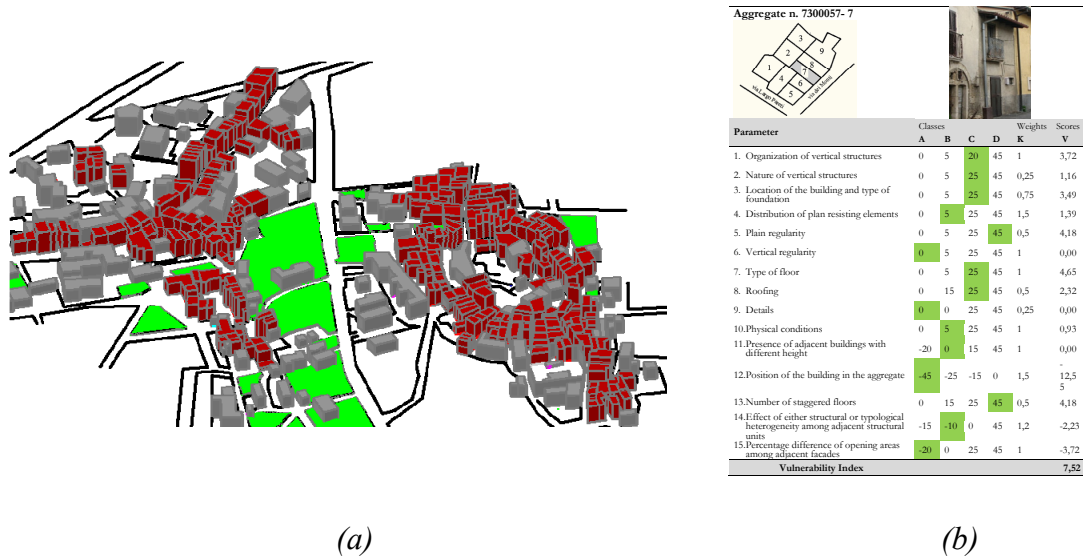
Figure 14. Seismic vulnerability assessment of the historic centre of Poggio Picenze: the examined aggregates (a) and a typical form filled for a given aggregate structural unit (b).

Therefore, the method has been applied to 51 masonry aggregates of building, composed of 284 structurally independent units (Fig. 14). For each building, the vulnerability index has been computed by filling the survey form explained in [8] and reported in the same Figure 14.

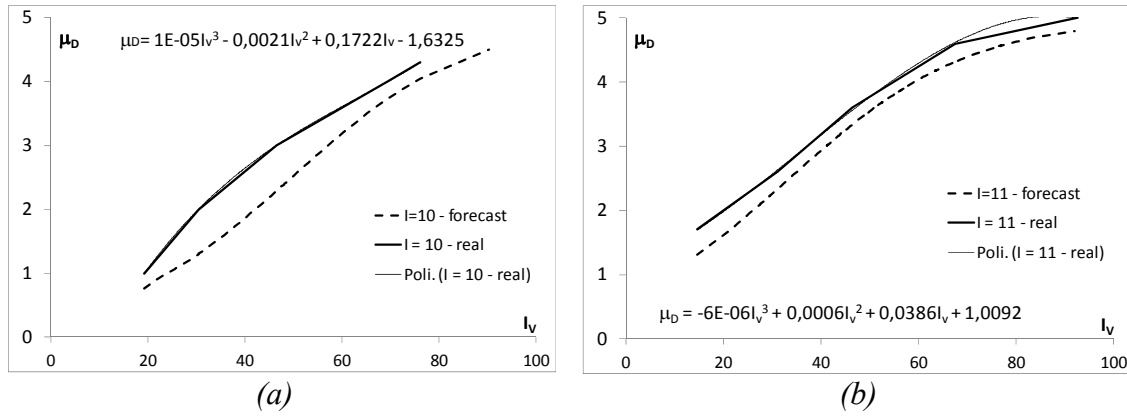
Figure 15. Comparison between the expected mean damage grade and the occurred one within the building aggregates of Poggio Picenze: the west zone (a) and the castle area (b).

From visual survey it was noticed that in the castle zone, the old buildings were heavily damaged, whereas minor damages were detected in the western and downhill parts of the town, where the foundation soil is based on the coarse-grained Pleistocene formation.

intensity levels detected in the centre ( $I = 10$  and  $11$ ), third-order polynomial equations between the average damage degree and the expected level of vulnerability, have been derived (Fig. 15).

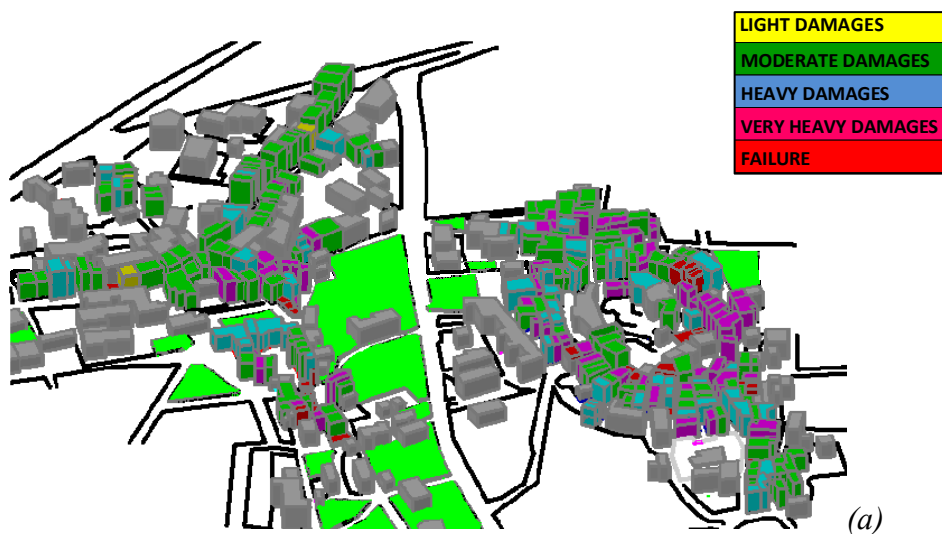
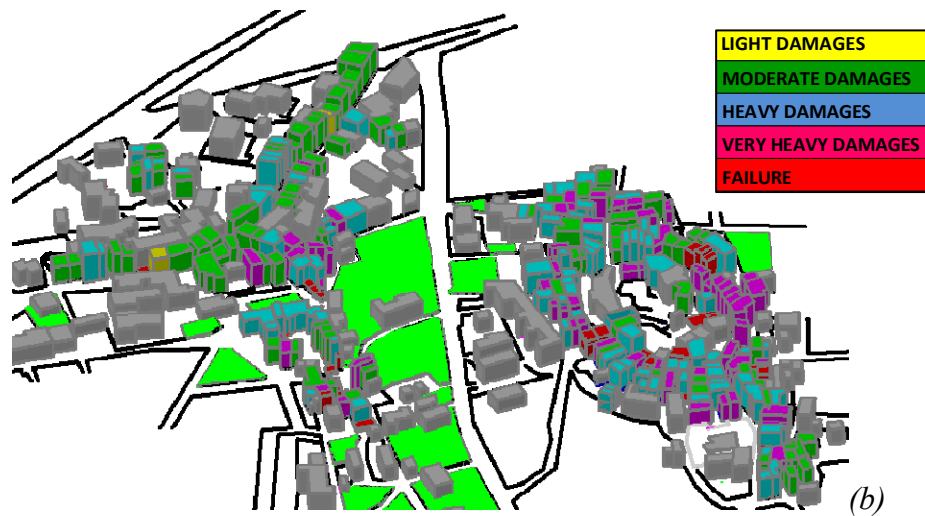
Figure 16. Comparison between forecast damages (a) and real ones (b) (continues).

The comparison between the real damages and the estimated ones which took place in two areas of the old town of Poggio Picenze is illustrated graphically in Figure 16.

The comparison shows that the proposed procedure does not provide a conservative estimate of the building aggregate behaviour under earthquake. This result could be produced from coupling near-fault conditions with site effects induced by the complex geological structures, which further contributes to increase the complexity of the earthquake ground motion effects.

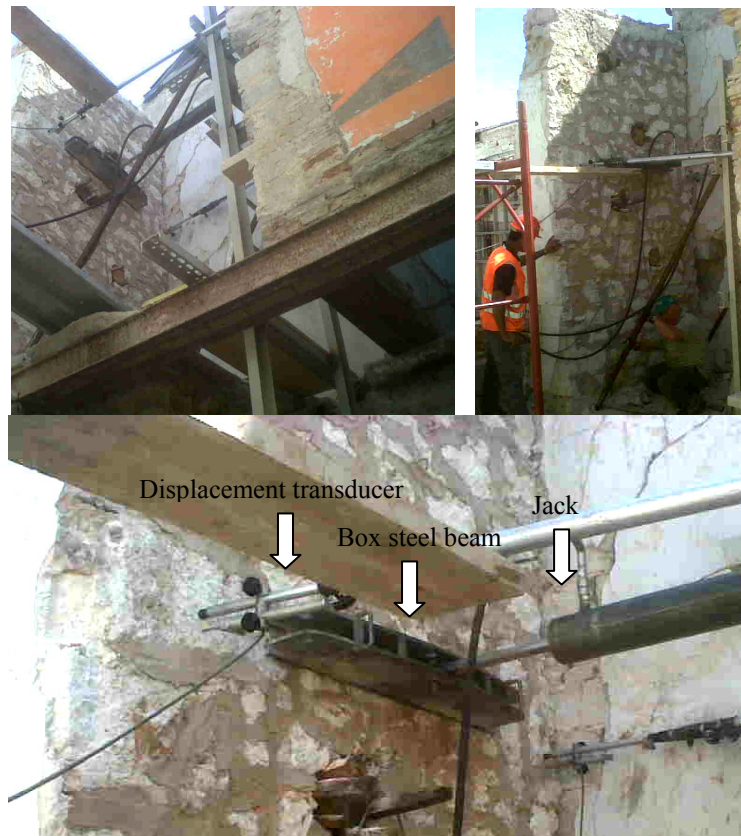
Figure 18. Details of the test set-up.

The panel, having width of 2.10 m, height of 4.00 m and depth of 0.60 m, was before cyclically tested by means of a hydraulic jack under “displacement-control”, with the possibility to produce displacements in alternate directions, and then pulled out with the same jack in the final test phase. The pushing action of the jack, placed at a height of 2.25 m, was applied to the panel through a rigid box steel beam anchored to it by steel bars. The test set-up was arranged to take advantage of panel position in the building scheme (Fig. 18).

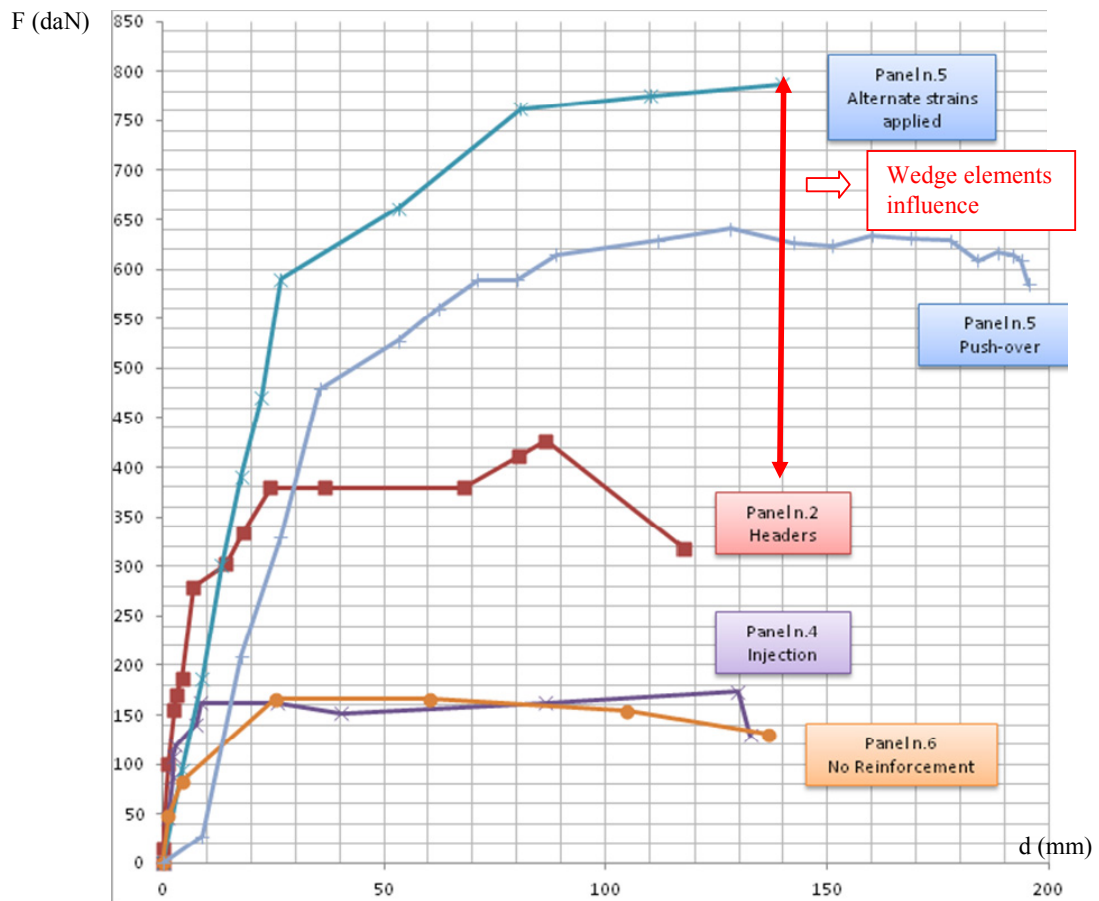
Figure 19. Comparison among strengthened masonry panels.

which, together with the wedge elements influence, allows to attain a total force four times more than the one of the original panel (see Fig. 19). In particular, the presence of stone wedge elements produce a strength increase two times than the one of the panel reinforced with concrete headers only.

The results of the presented experimental activity have demonstrated the effectiveness of the proposed consolidation technique, which can be usefully applied for strengthening L'Aquila building masonry.
